MASONIC TEMPLE
310 East Chicago Street/Elgin

PICTORIAL SURVEY
OF EXTERIOR REHABILITATION

February 28, 1997

DIXON ASSOCIATES, LTD. / ARCHITECTS
202 West Main Street
St. Charles, Illinois 60174
(630) 377-9399
(630) 377-9388 fax

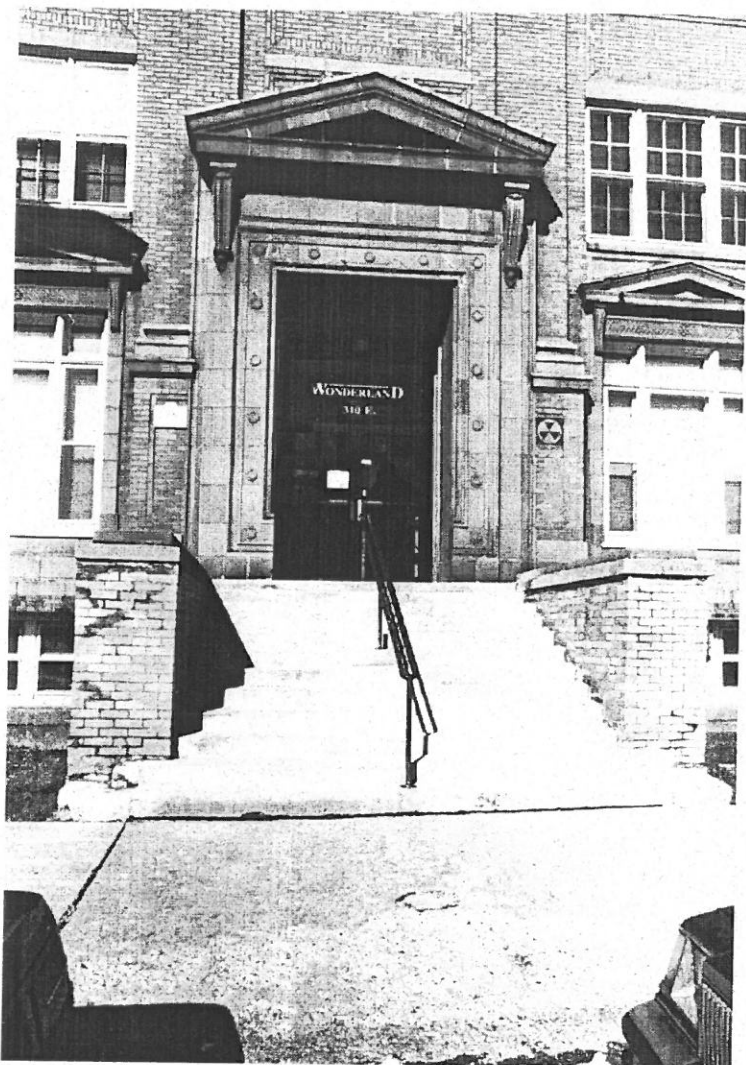
1
South Entrance
showing entry steps to be r

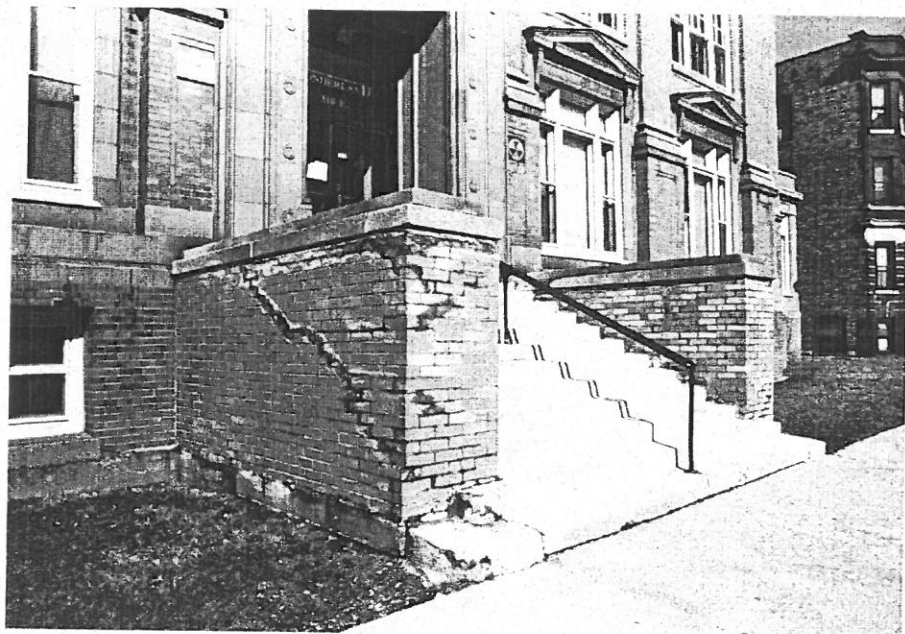
2
South Entry Steps

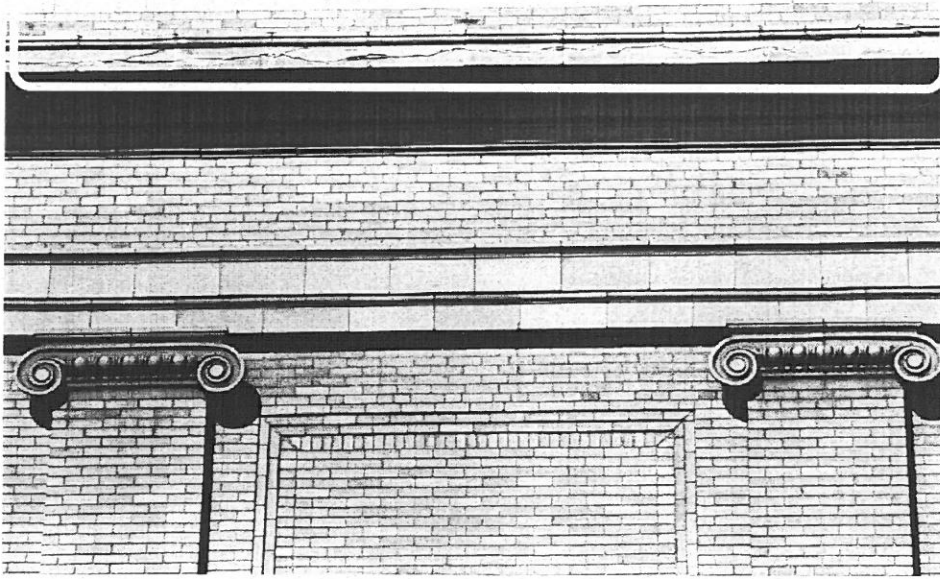
3
Deteriorating terra cotta at
south elevation

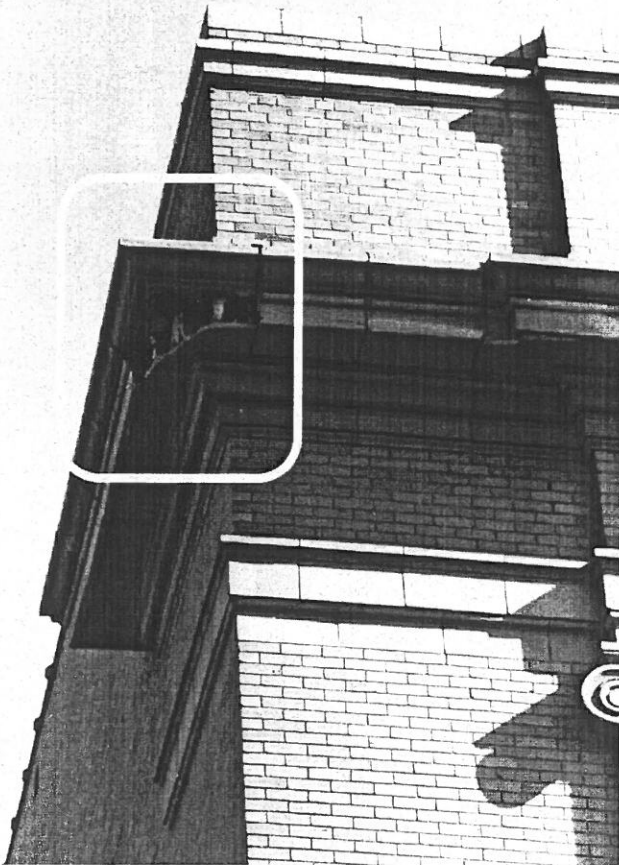
4
Terra cotta piece at northwest
corner to be replaced

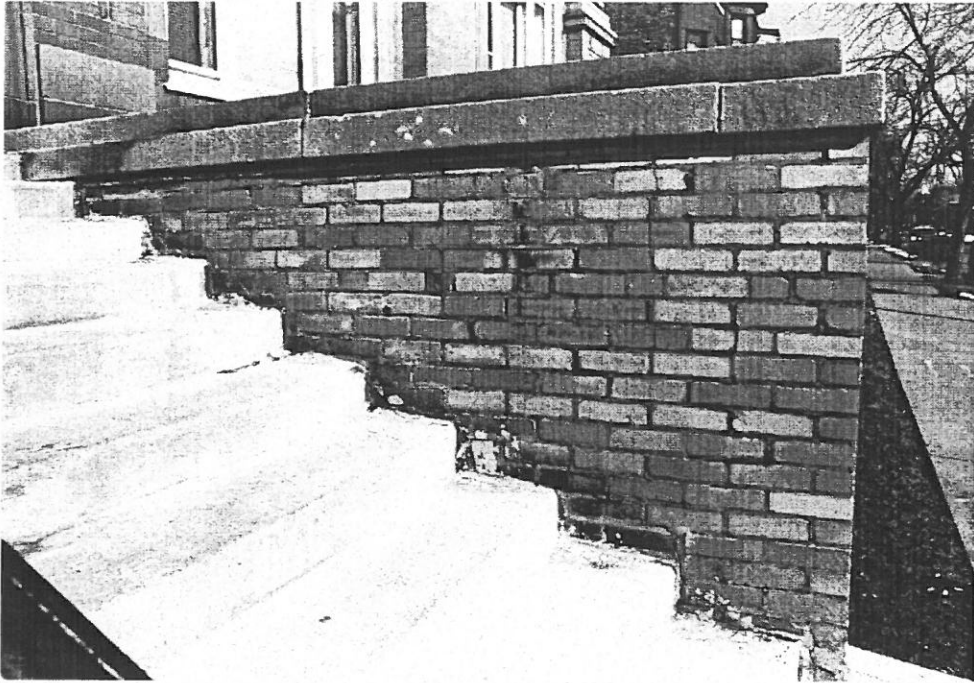
5
Detail at south entry steps
to be reconstructed

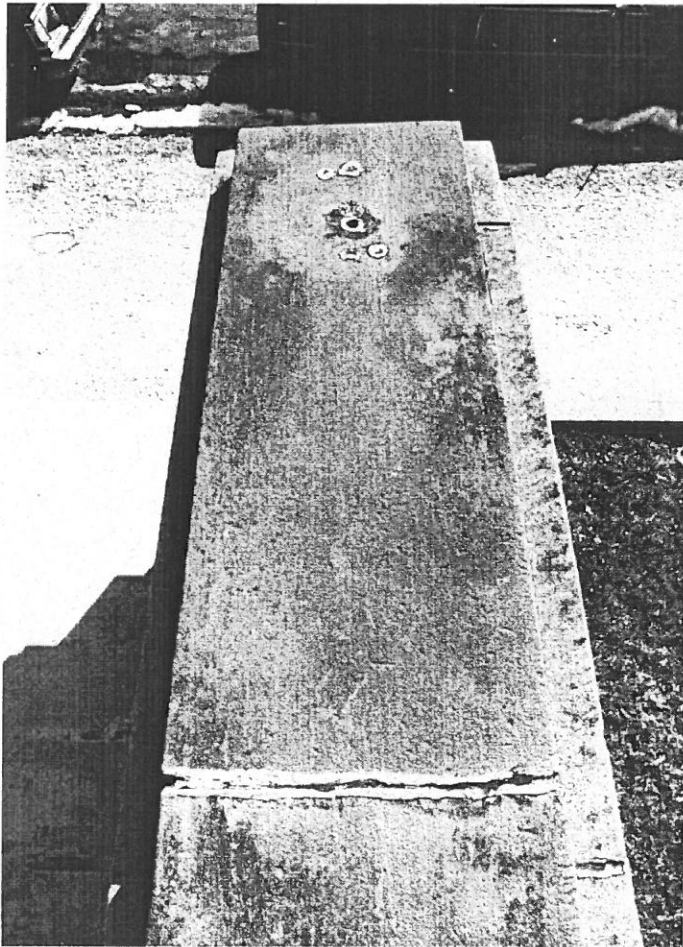
6
Top of stone cap at south entry
stairs showing electric conduit
locations. New light fixtures of
an appropriate design are to
return to two such locations.

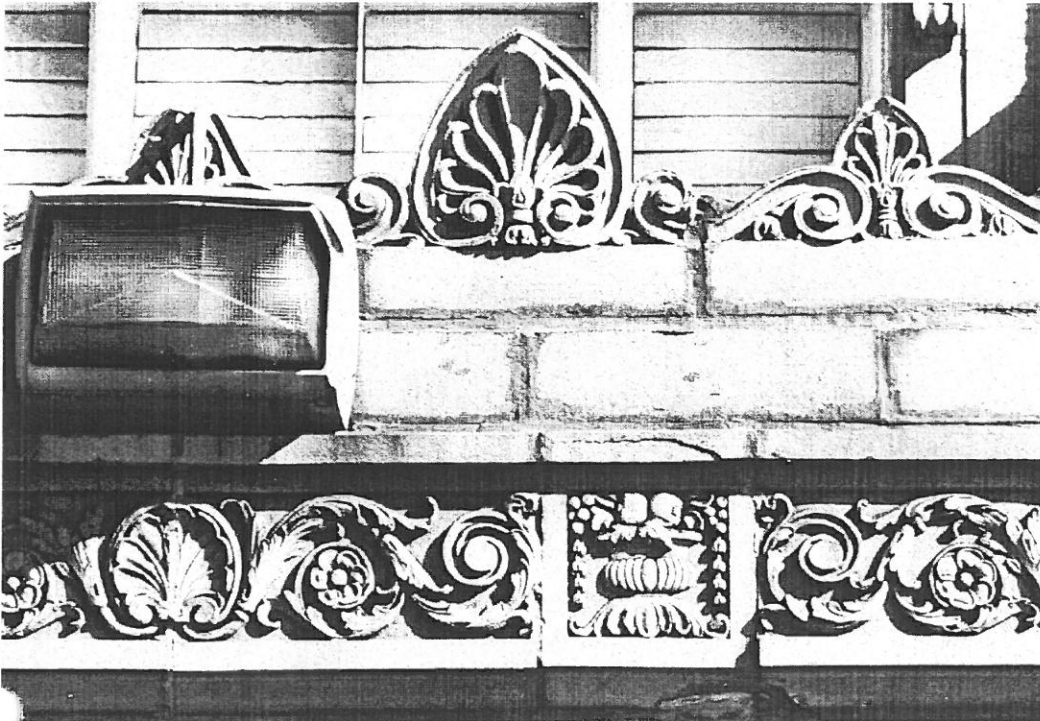
8

Terra cotta and brick detail showing inappropriate light fixture to be removed (at west entry)

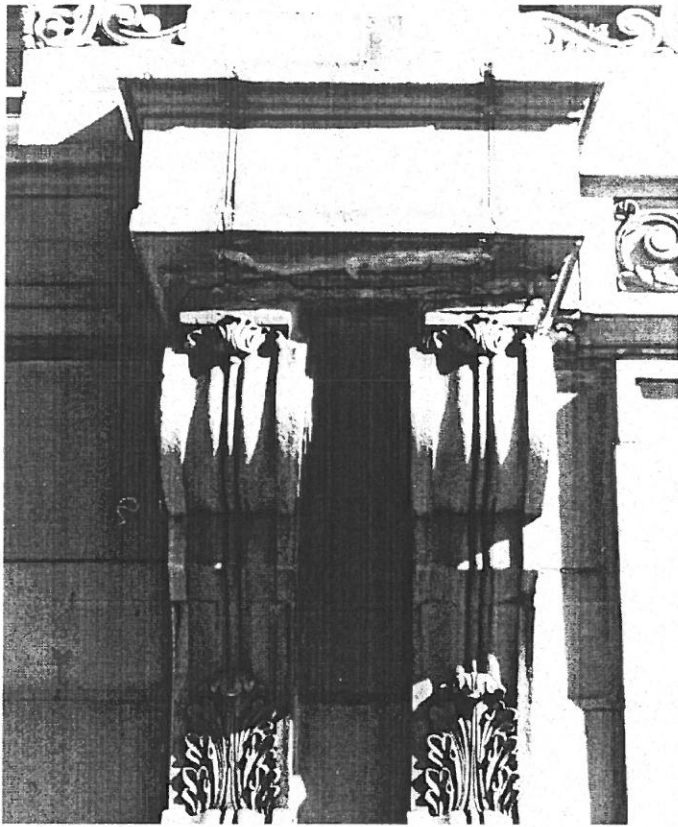
9
Detail at west entry showing terra
cotta requiring removal, structural
repairs and replacement

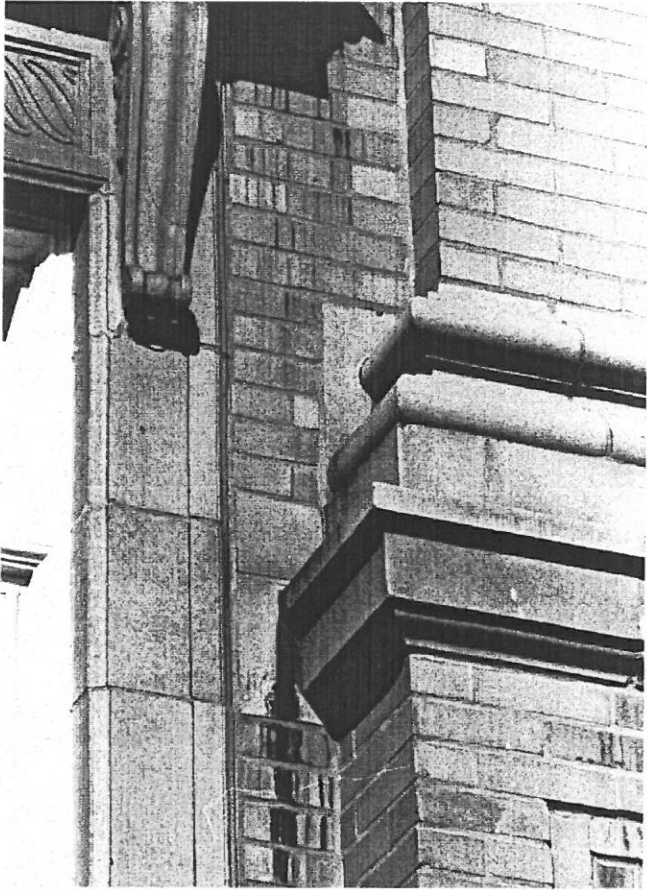
11
Detail at south elevation showing
stained masonry to be cleaned

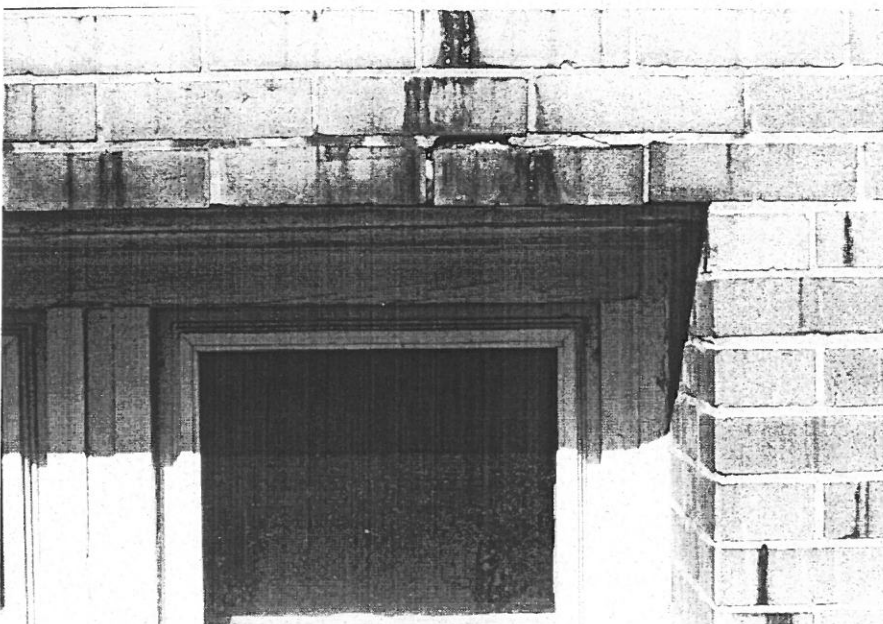
12
Detail showing
tuckpointing required
to stabilize masonry

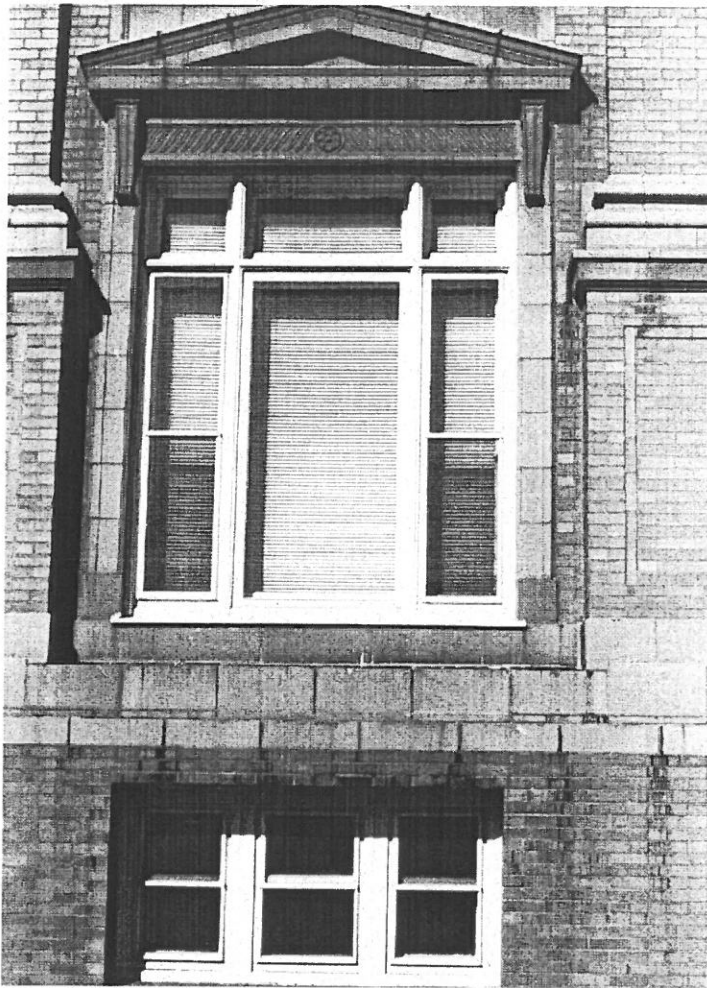
13
Typical window group requiring
replacement storms and
painting

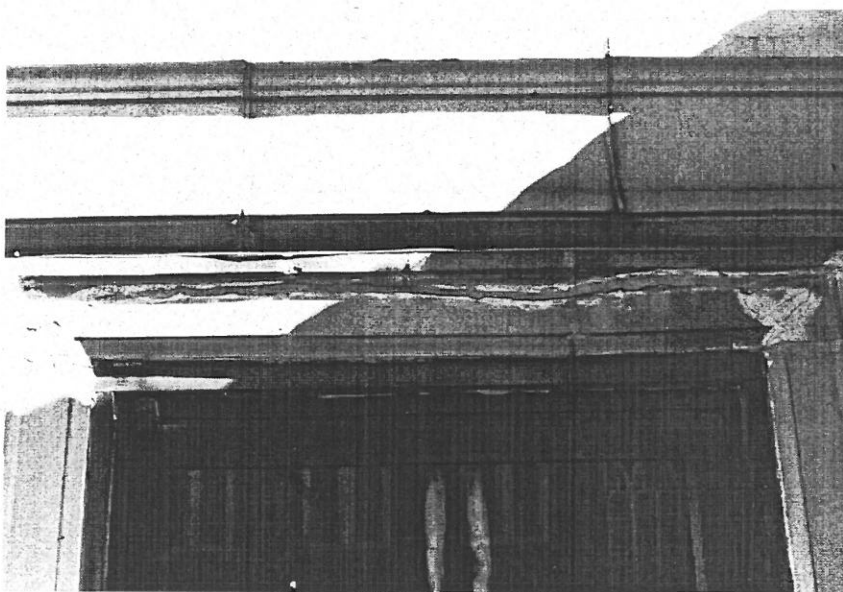
14
Detail showing repairs
required at window head

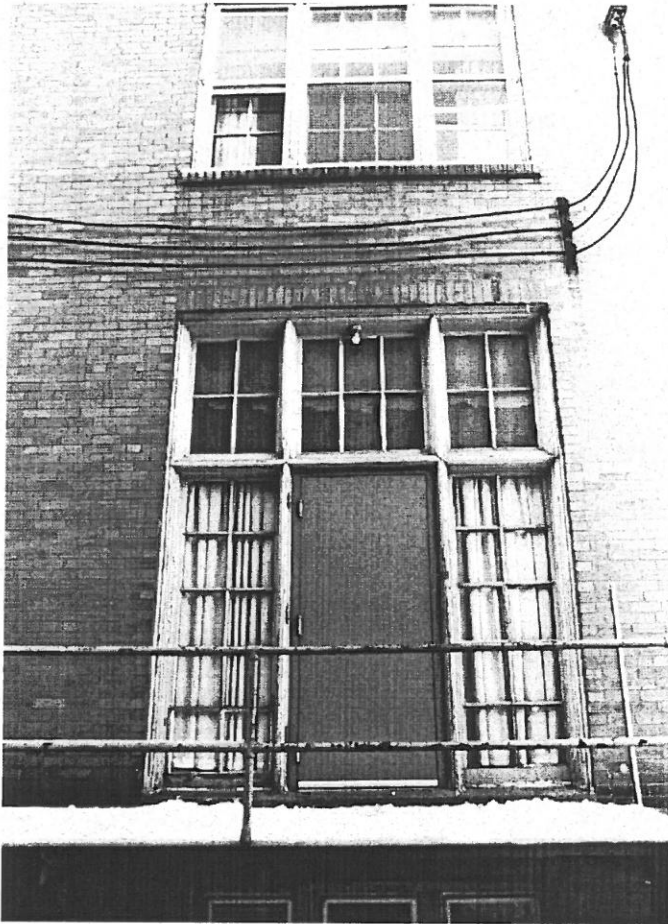
15
Detail at North Elevation
showing window/door group and
railing requiring painting

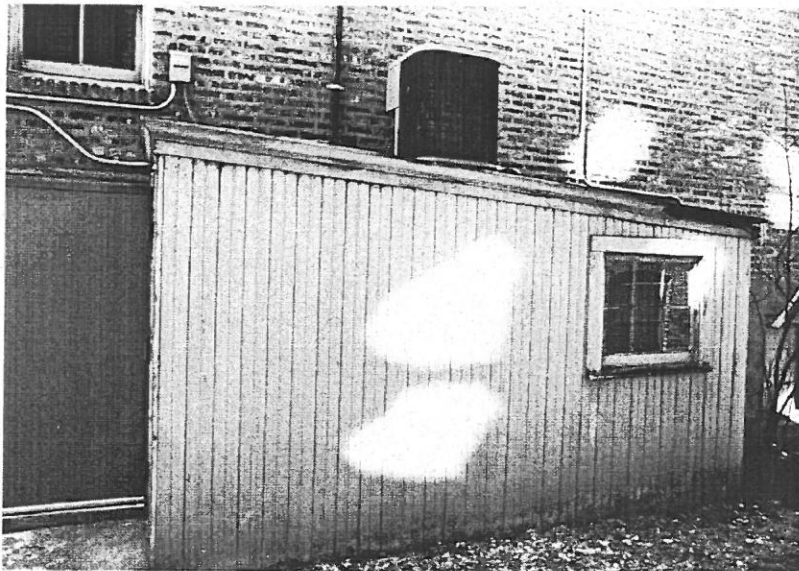
16
Shed at east side of
building requiring
painting and repairs
